Collision of Tankship *Eagle Otome* with Cargo Vessel *Gull Arrow*  
and Subsequent Collision with the *Dixie Vengeance* Tow  
Sabine-Neches Canal, Port Arthur, Texas  
January 23, 2010

NTSB/MAR-11/04  
PB2011-916404

# Marine Accident Report

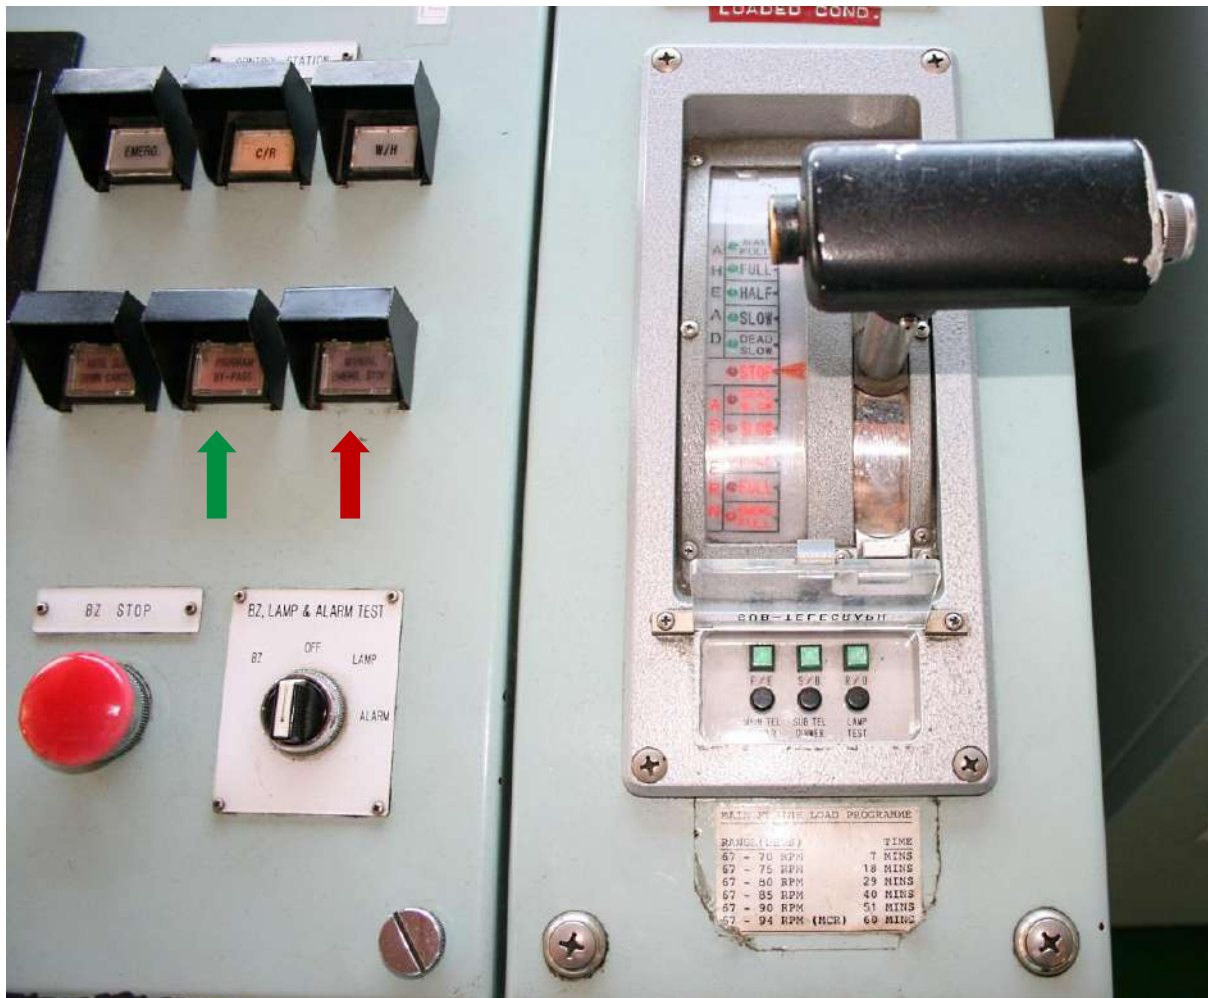
effectiveness. The *Eagle Otome* master told investigators that, to speed implementation of the full ahead order, he then used the engine order telegraph, which was set to bridge control, to increase the tankship's speed from full ahead to "navigational full ahead." This would gradually increase the tankship's propeller revolutions from about 65 rpm to 90 rpm.<sup>22</sup> To complete the navigational full ahead, a specific button labeled "program by-pass" on the engine control console must be pushed.<sup>23</sup> In his attempt to activate the navigational full ahead, however, the master inadvertently pushed a button marked "manual emergency stop," which was identically shaped and located immediately adjacent to the "program by-pass" button (figure 8).

**Figure 8.** Section of the engine control console on the *Eagle Otome*. Activating the navigational full ahead required pushing the button marked with a green arrow. However, the master inadvertently pushed the "manual emergency stop" button, marked with a red arrow. (The arrows were added to this image; they are not featured on the actual engine control console.)

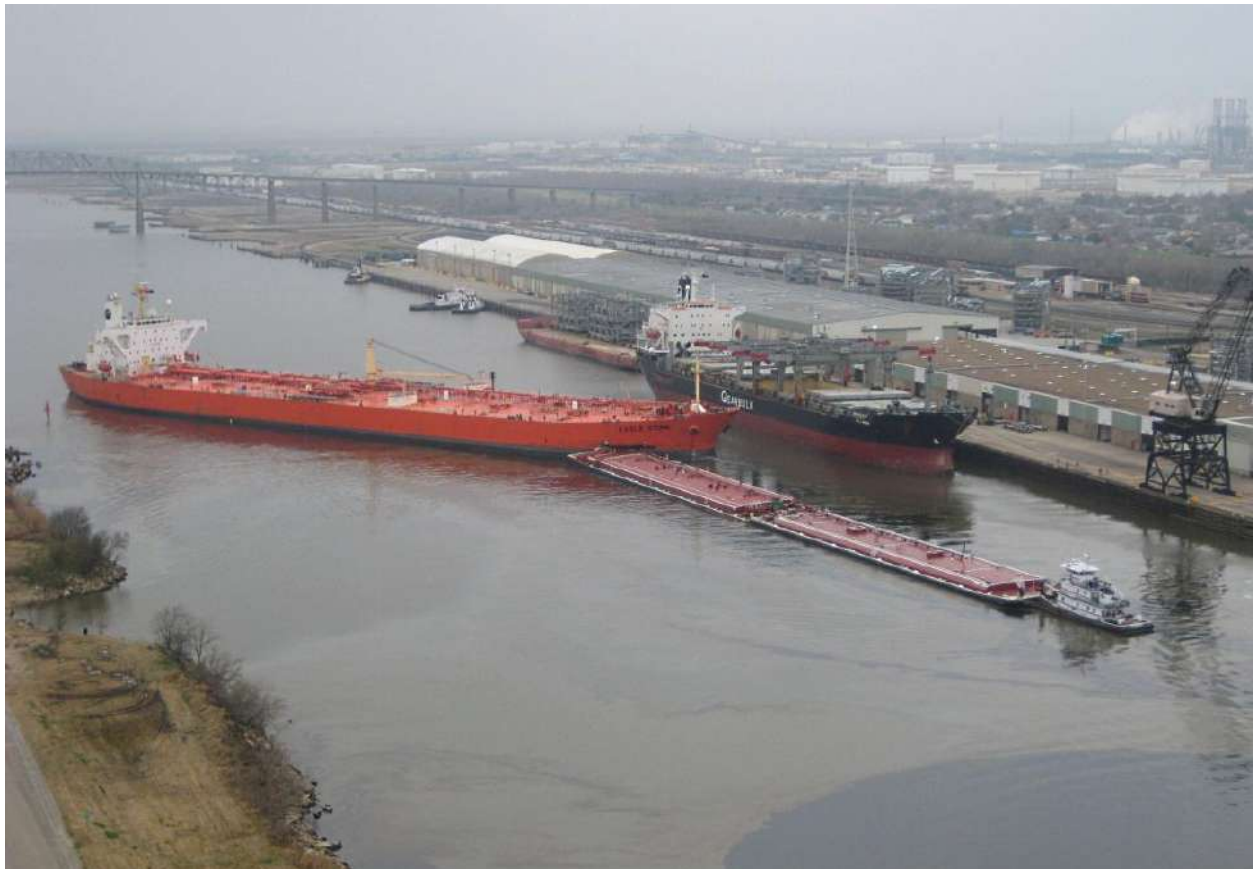
As a result of the breach, an estimated 462,000 gallons of crude oil spilled into the water. The vessels remained together in the center of the canal while pollution response procedures were initiated (figure 9). (For more information, see section “1.9 Oil Spill and Recovery Efforts.”)

**Figure 9.** The three vessels after the accident. Overflight photo by the Coast Guard, looking west-southwest.

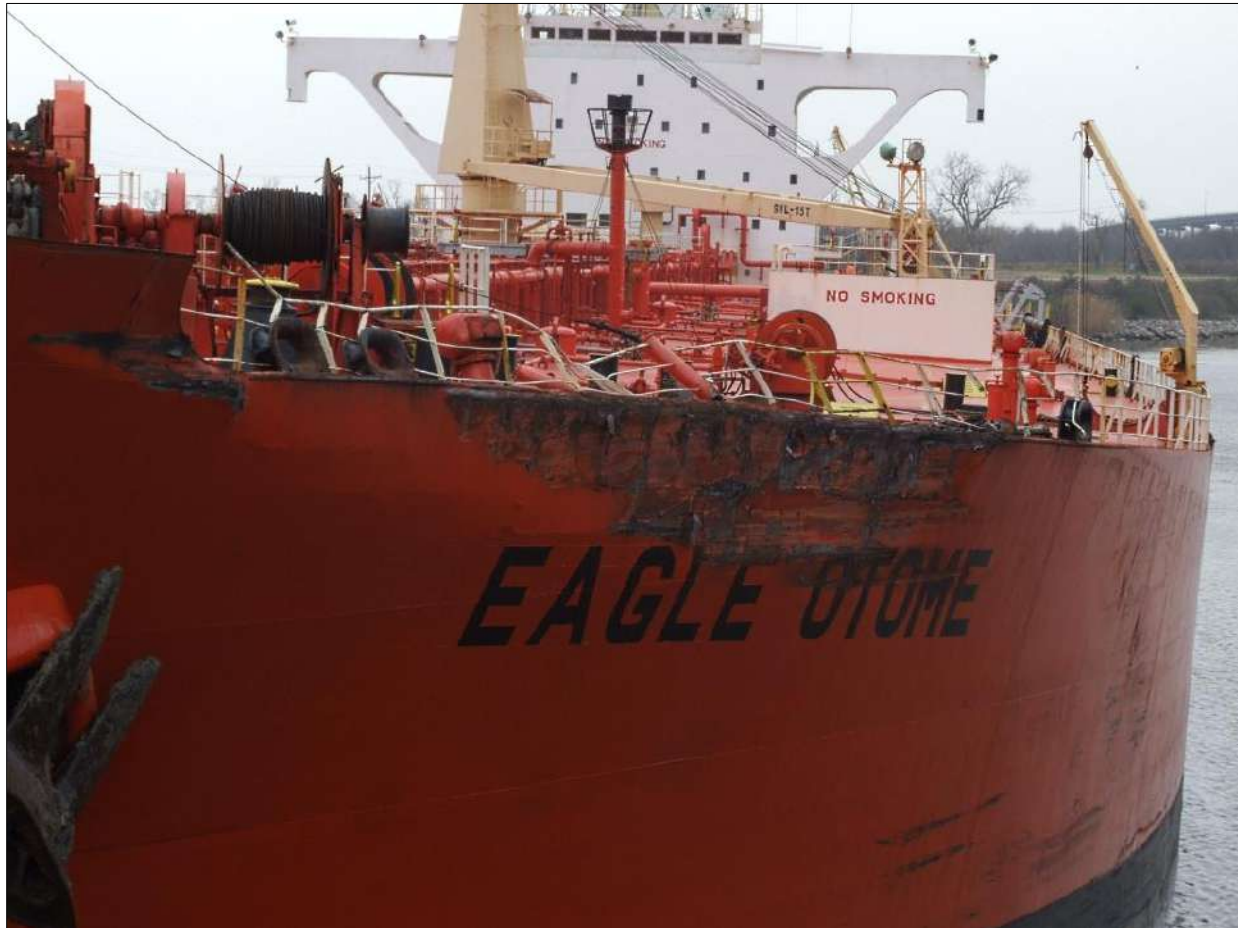
**Figure 10.** Portside damage to the *Eagle Otome*.

side. The damage to the portside shell plating and internal structure extended horizontally about 55 feet and down about 12 feet from the main deck. The damaged compartments in this area were the No. 1 port ballast tank, the forward cofferdam,<sup>30</sup> and the bosun store room, and involved buckling, detachment, and fracturing of the internal structure, which was inset about 3 feet as a result of the impact. The main deck plating, deck railings, and port bulwark were also damaged in this area (figure 10).

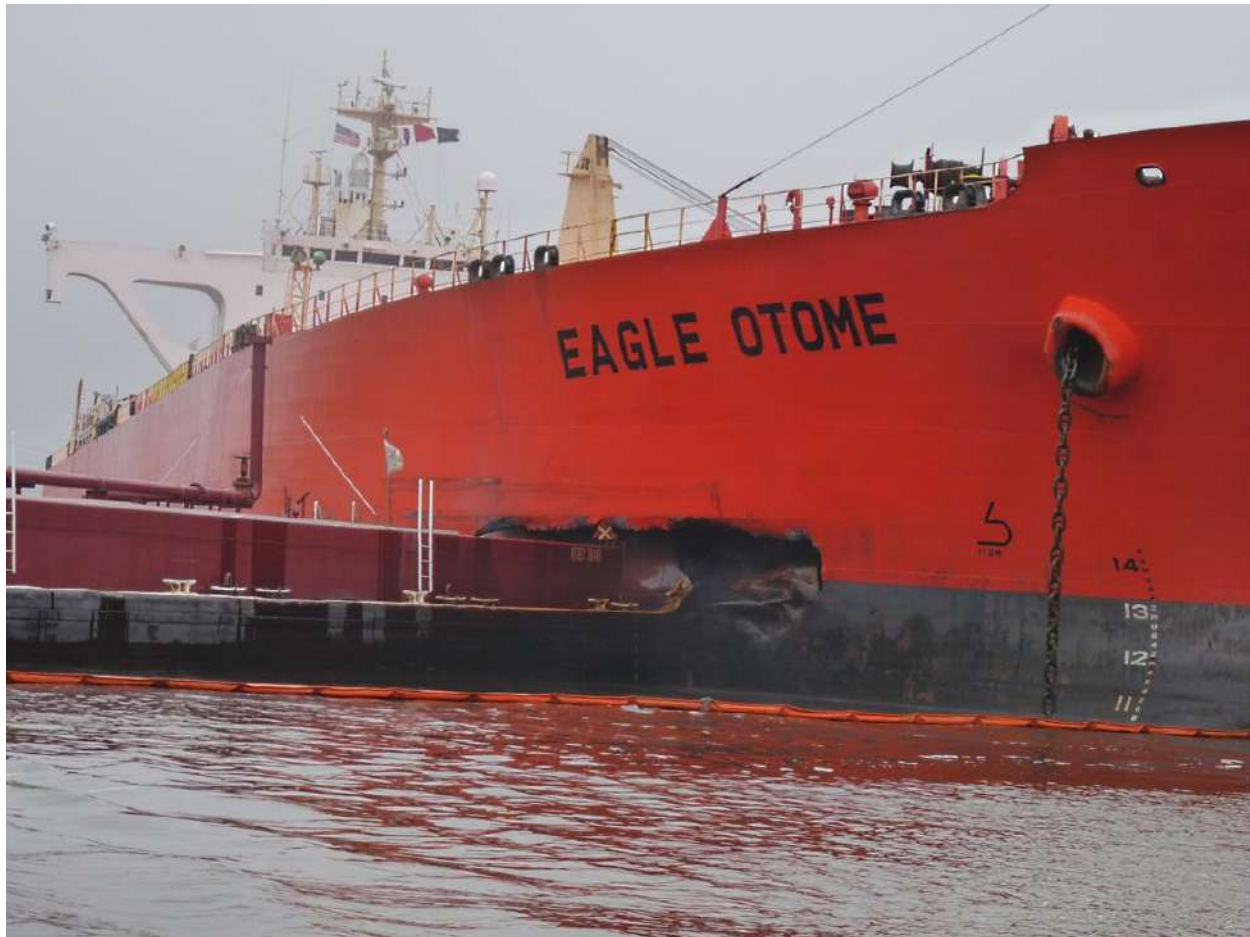
**Figure 11.** Starboard side of the *Eagle Otome*, with the Kirby 30406 lodged in it.

The subsequent collision with the *Kirby 30406* created a hole in the *Eagle Otome*'s starboard hull about 30 feet aft of the tankship's bow, above the waterline (figure 11). The side shell plating was punctured and inset across an area about 43 feet long and 10 feet high, extending from the No. 1 starboard ballast tank to the forward cofferdam. Frames and stringers in this area were buckled, fractured, and completely detached in several locations. The damage to the *Eagle Otome* was estimated at \$1.5 million.

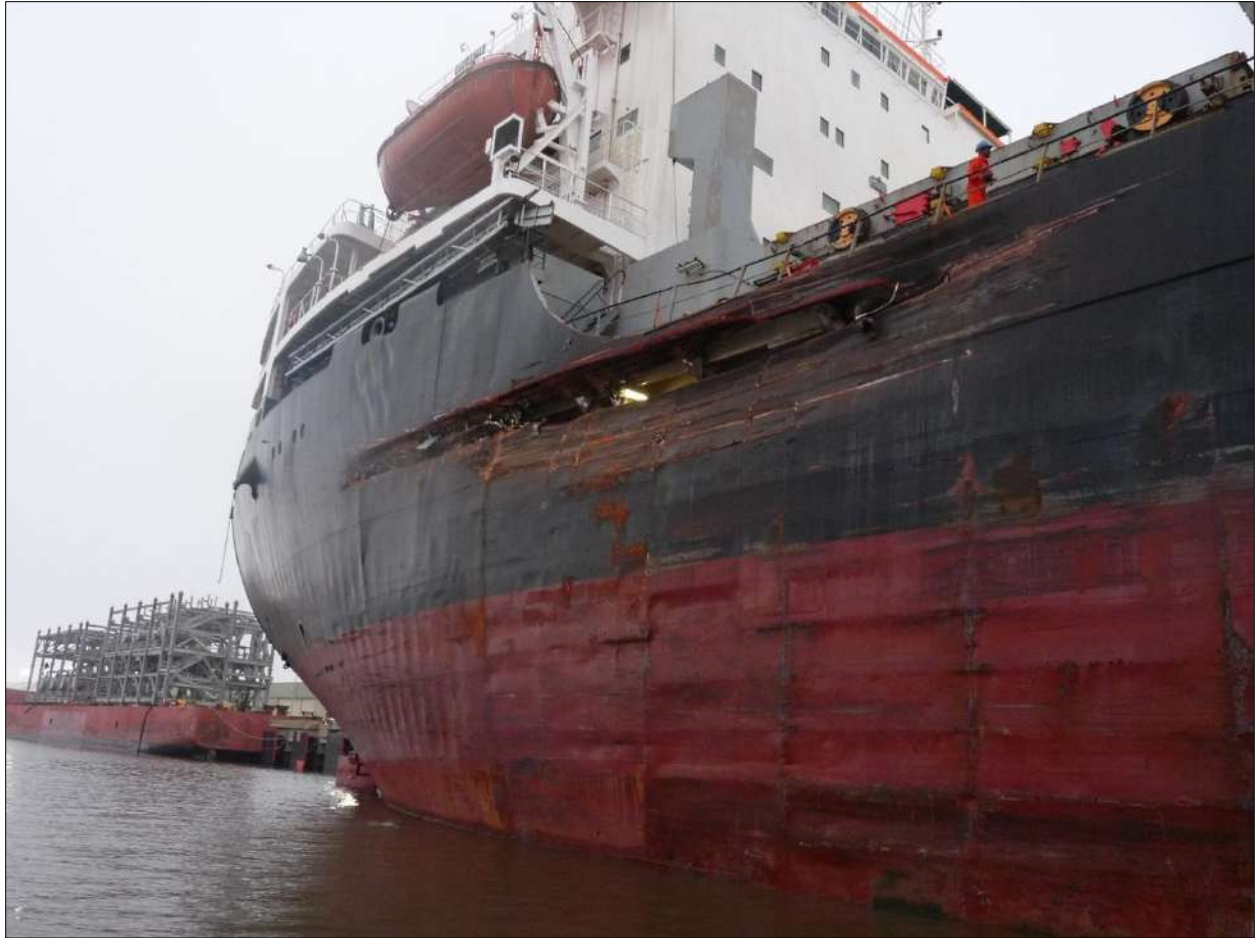
**Figure 12.** Damage to the *Gull Arrow*.

The *Gull Arrow* sustained a gash about 100 feet long and 3 feet high just below its starboard-side gunwale.<sup>31</sup> According to a surveyor's report, the structural frames in this area were buckled, with six frames broken and distorted. The shell plating below the gash was inset between 1 and 3 feet. On the main deck, 16 sections of handrails, stanchions, and brackets were bent over to an angle of about 45 degrees (figure 12). In the interior spaces of the damaged area, including the engine machine shop and maintenance tunnel, damage was sustained to electrical conduits and to various piping systems, such as sewage and steam. The *Gull Arrow* also sustained damage to its portside hull when the impact pushed the ship into the concrete wharf. On the portside, a 10-foot-high by 115-foot-long section of shell plating, between frames 42 and 79, was inset about 3 inches.

No fuel tank was breached and no fuel was released from the *Gull Arrow*. The damage to the *Gull Arrow* was estimated at \$381,000.

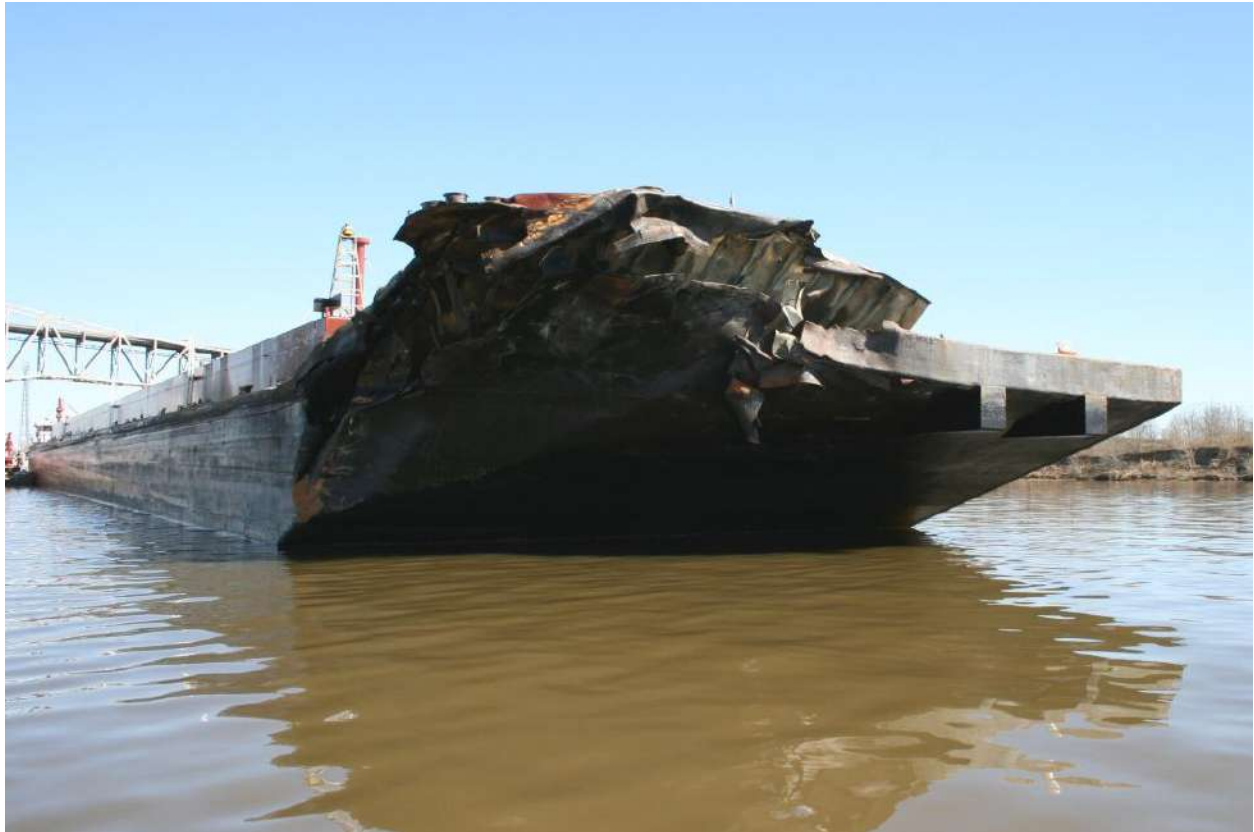
**Figure 13.** Damage to Kirby 30406.

The bow (or rake) of the barge *Kirby 30406* was peeled back in the collision with the *Eagle Otome* (figure 13). The barge's void space on its starboard-side rake was crushed, and about 5 feet of the rake had curled up under the hull plating of the *Eagle Otome*. The cargo tanks remained intact, and no aromatic concentrate product was released.

The damage to the *Kirby 30406* was estimated at \$35,000.
