Collision of Tankship *Eagle Otome* with Cargo Vessel *Gull Arrow*  
and Subsequent Collision with the *Dixie Vengeance* Tow  
Sabine-Neches Canal, Port Arthur, Texas  
January 23, 2010

NTSB/MAR-11/04  
PB2011-916404

# Marine Accident Report

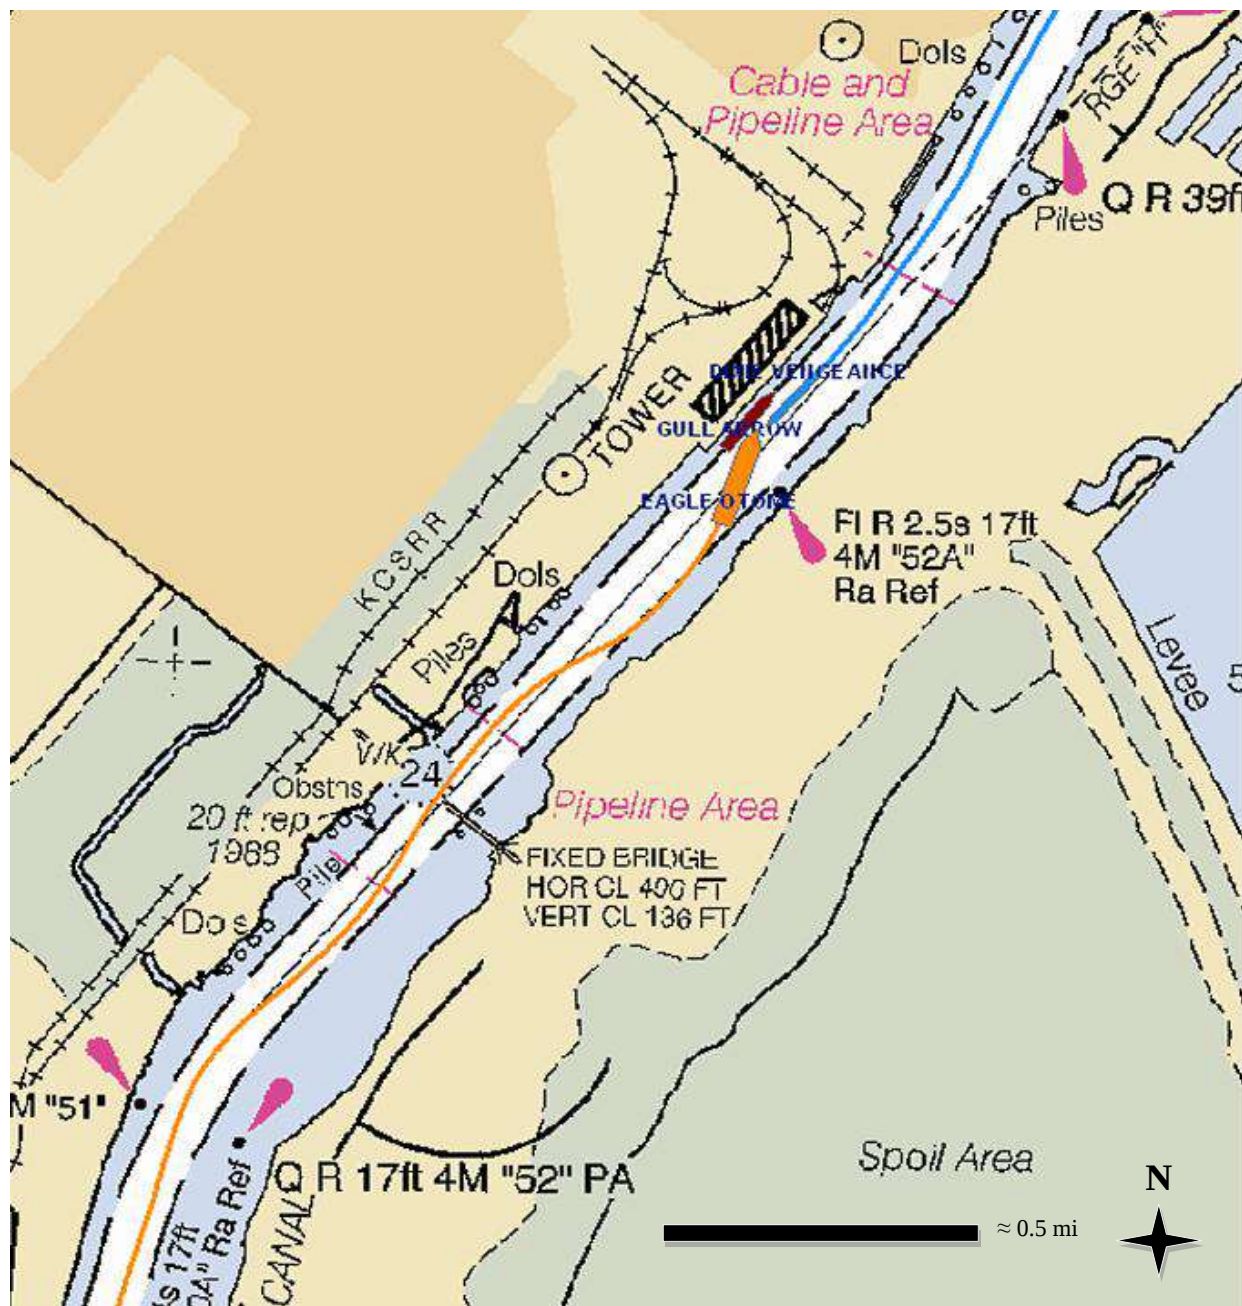
When the *Eagle Otome*’s starboard bow came close to the east bank, the tankship began sheering to port, despite the hard to starboard rudder command (figure 7). At 0933:14, the first pilot asked the second pilot, “Will you talk to this next tow?” The second pilot answered, “What do you want me to tell them? Just one whistle or look out here we come?” The first pilot replied, “One, yeah, look out, the one there is *Vengeance*.” However, neither the S-VDR nor the VHF radio recordings indicated that the second pilot contacted the towboat as the first pilot instructed him to do.

**Figure 7.** Trackline of the *Eagle Otome*, obtained from the tankship's S-VDR, overlaid as an orange line on NOAA chart 11342, and trackline of the *Dixie Vengeance*, obtained from automatic identification system (AIS)<sup>21</sup> data, overlaid as a blue line.
